January 2018

The Case Of The MOSFET Failure

by Paul L. Schimel, PE

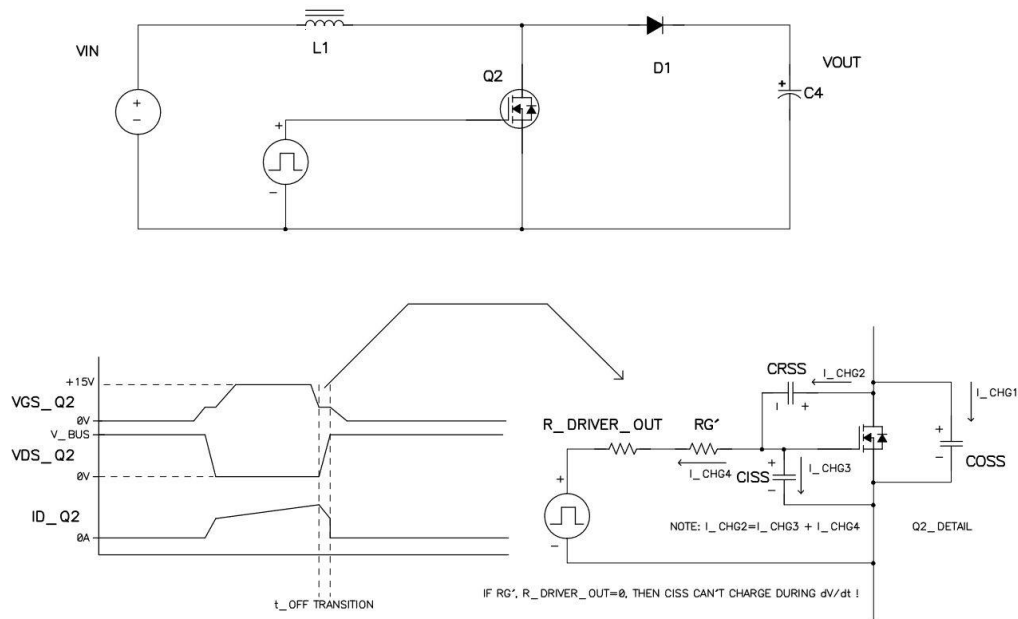
But the fast commutation.....was it then possible that the fast charging of the C_{OSS} of the MOSFET at the turn-off coupled through C_{RSS} into the gate structure? There is a logical path for this, and with fast enough dV/dt on C_{OSS} , it is possible to couple charge through C_{RSS} into the gate (see Fig. 1). This is why most MOSFETs specify a $V_{DS} dv/dt$ speed limit in the datasheet. And R_g' is slightly higher, so even with a good driver and lowest dynamic and static offstate impedance at the gate source terminals, there is some series resistance in the circuit. While the gate connection to the driver may show no nuisance turn-on, the R_g' may allow this on the internal gates.

Is that possible? Yes. And if it did occur, I'd expect to see the MOSFET turning back on briefly during the fast commutation. There would be a fast glitch drop in V_{DS} while it was supposed to be climbing to the rail voltage. That would cause a lot of dissipation in a short time. Very high current. A switchthrough event.

Fig. 1. The Cdv/dt turn-on path that causes false turn-on in a MOSFET.

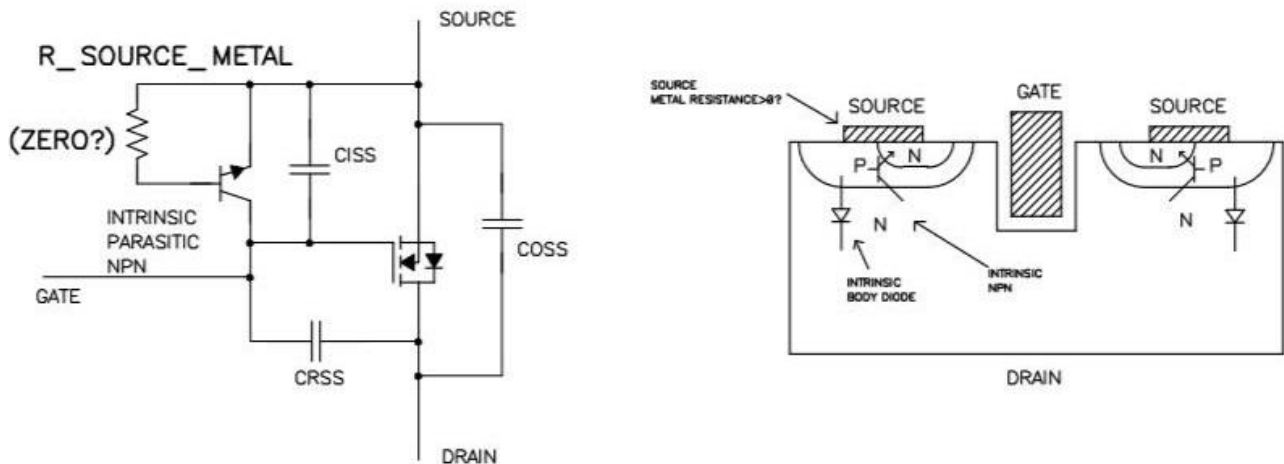
The other possibility is that the source metallization of the MOSFET had a higher resistance. Recall, the source metallization is the stuff that shorts the BE junction of the intrinsic NPN in most any cross section. While we assume that this is zero, what if it were a nonzero resistance? By the same coupling mechanism, the fast commutation could couple charge into the base of this intrinsic NPN through C_{RSS} . If the metallization resistance were high, this could cause the BE junction to turn on (see Fig. 2).

At this point the gate command would mean absolutely nothing. The MOSFET would turn on uncontrollably at this instant. This too could cause the fast heating and topside damage. Modern MOSFET designs guard against this heavily. There is purposed metal over both the N and P well to short this BE junction as source terminal of the device.

Fig. 2. A parasitic NPN device in a MOSFET, BE shorting resistance and turn-on path.
